**MARYLAND HISTORICAL TRUST  
DETERMINATION OF ELIGIBILITY FORM**

Property Name: Richard J. Hesse Farm Inventory Number: G-V-A-156

Assess Visual Effects of Allegheny Heights Windpower

Richard J. Hesse Farm G-V-A-156  
Gortner  
Garrett County  
USGS Table Rock 7.5 minute quad map

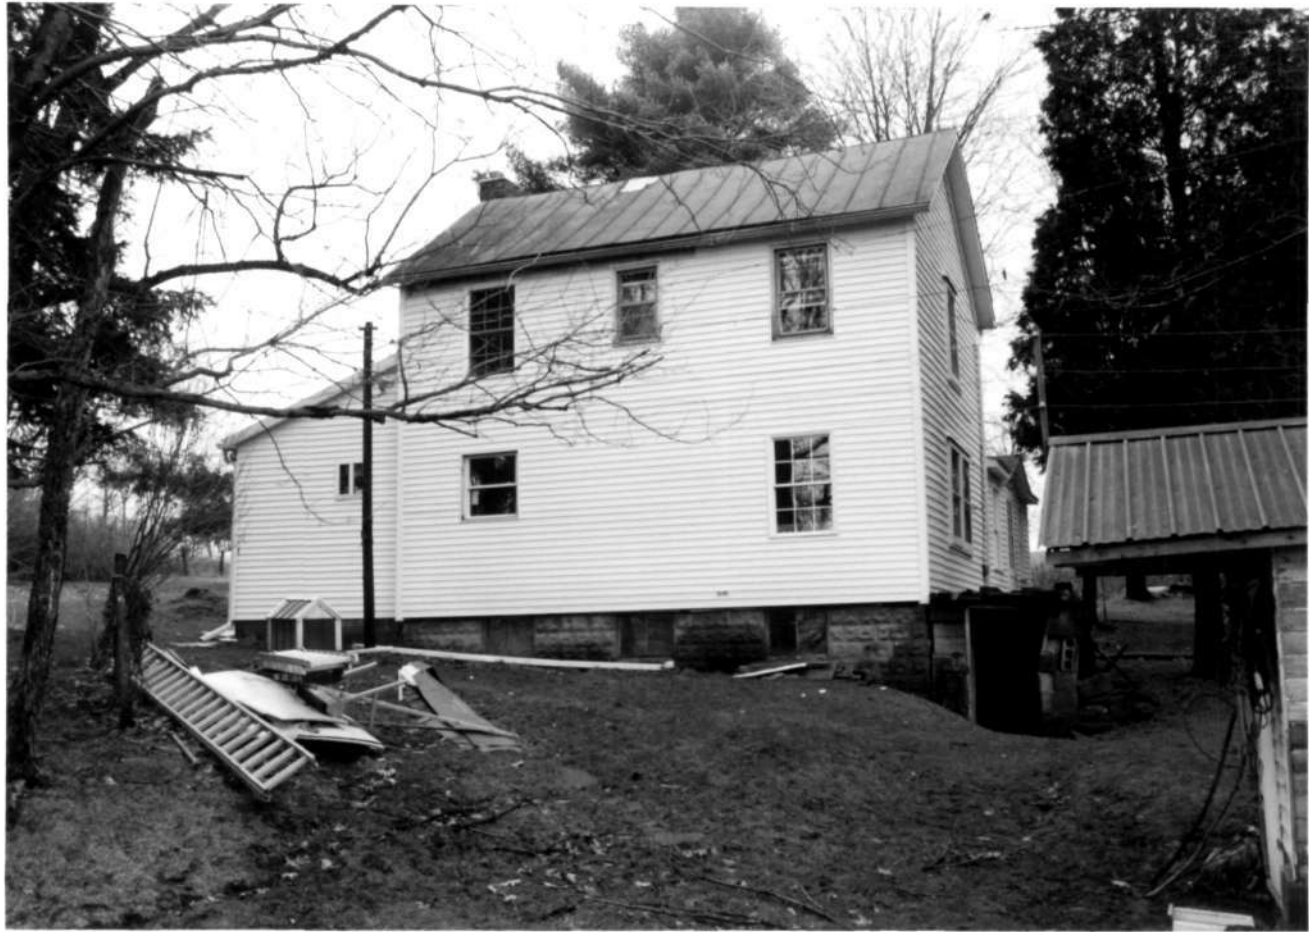
LOT 2

The Richard J. Hesse Farm is located on the west side of Pleasant Valley Road near where Shady Dell Road joins Pleasant Valley Road. The house is sited in a slight depression and accessed by an unpaved farm lane. A line of evergreen trees defines the house lot on the east side. Open fields east of the tree line rise gently upwards affording distant views of Backbone Mountain. A hill of Little Mountain rising to 2600 feet above mean sea level blocks all views southward of Backbone Mountain. The property comprises a house, two milkhouses, a spring, two ruined chicken coops, and an equipment shed. The original large barn associated with the property and located south of the house has been removed.

The house was constructed ca. 1890 and appeared in this approximate location on the USGS Oakland quadrangle map surveyed in 1899 and published in 1908 (USGS 1899, 1908). The main house was described in 1981 as vertical plank construction and is clad with horizontal wood siding with cornerboards. Asphalt shingle siding was noted in the upper north gable end. Recent renovation work includes the installation of vinyl siding on the west elevation. The house comprises two, two-story sections. The three-bay by one-bay west section intersects

DWELLING - VIEW SE

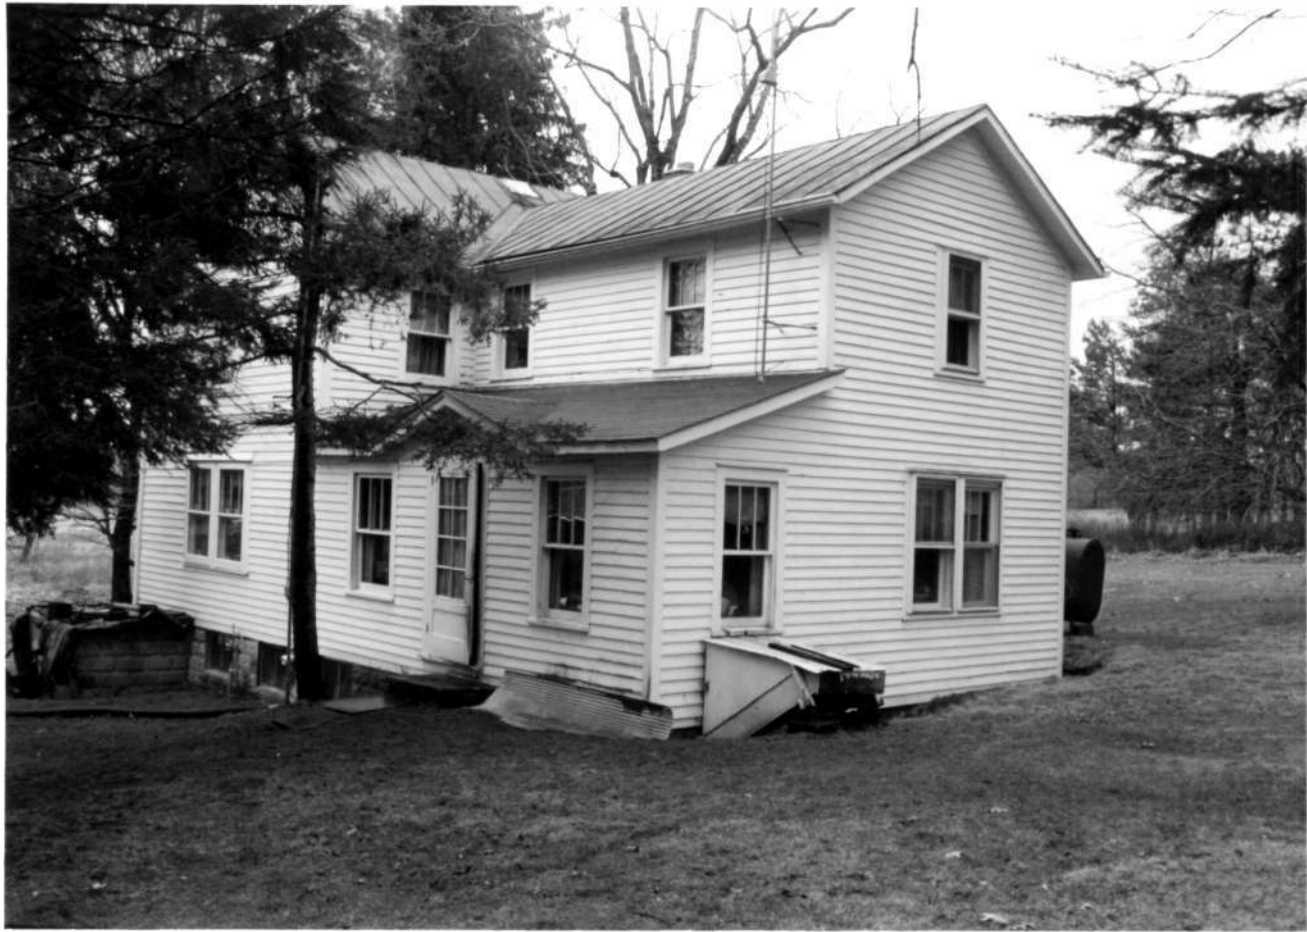
MIHP - G-V-A-156  
RICHARD J. HESSE FARM  
GARRETT COUNTY, MARYLAND  
RCGA  
JANUARY 2005  
~~MD SAPO~~  
DWELLING - VIEW N  
2 OF 2

perpendicularly with a two-bay by one-bay section on the east to form an L-shaped ground plan. The house may originally have been configured as a main block with ell, but renovated to reflect a gable front and wing form (McAlester 1990: 92). The house rests on a rusticated concrete-block foundation. The roof ridge of the east section joins the west section slightly lower than roof ridge of the west section. The roofs are sheathed with standing-seam metal and have an enclosed eave. The primary entry is located in a one-story, shed-roofed, enclosed porch that spans the south elevation of the east section of the house. The doorway to the porch contains a single wood panel door with eight lights. The enclosed porch has a concrete block foundation with one-by-one-light sliders. The older wood-frame, six-over-six-light windows in the west end are being replaced with modern one-over-one-light units. A single six-over-six-light window remains in the south gable end. The east elevation retains the wood-frame, three-over-one-light, double-hung sash windows. These windows have wide wood casings. A one-story, vinyl sided bathroom addition constructed since 1981 projects from the north gable end. This addition also contains a doorway with a modern door.

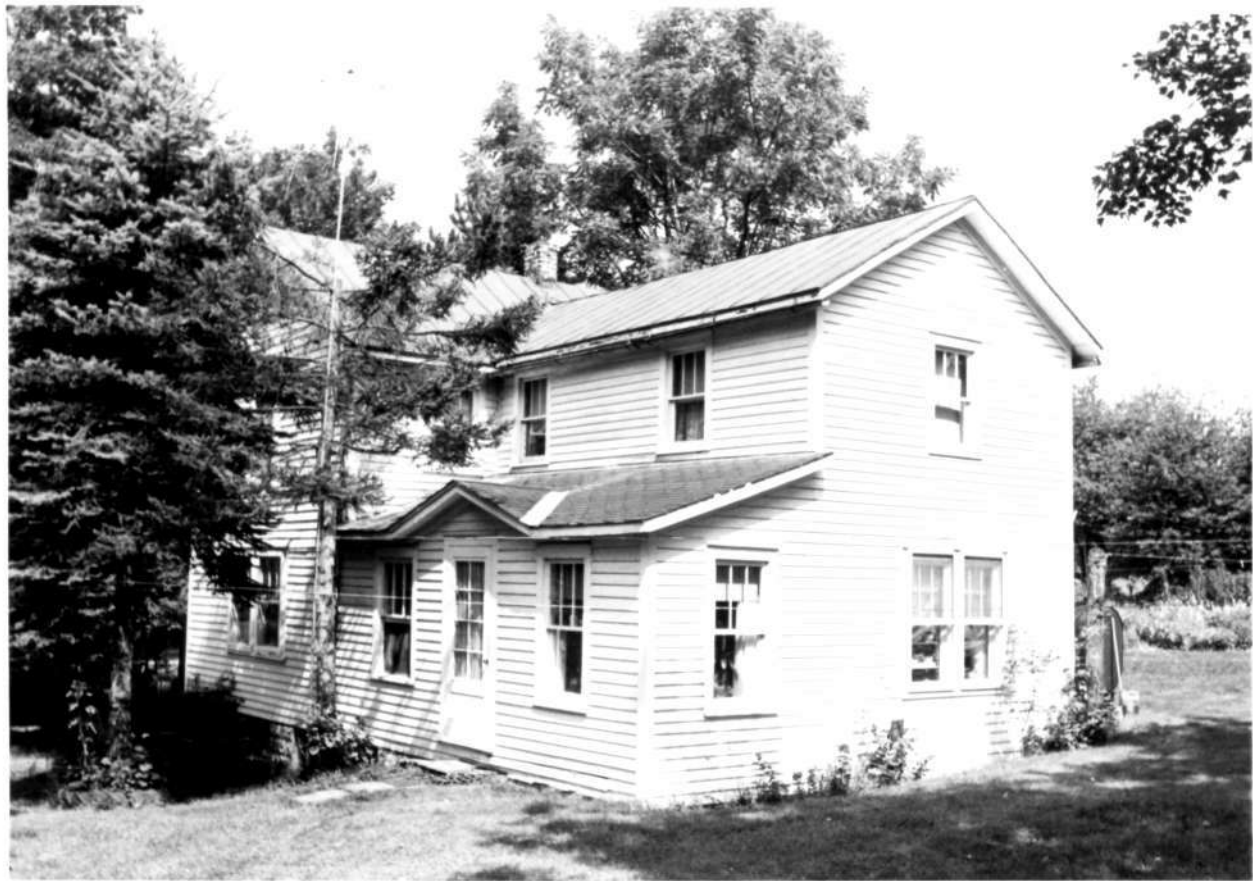
SW & SE elevations

This verticle plank constructed house is situated in a hilly, semi-wooded area on Pleasant Valley Road, approximately 3/4 miles east of Gortner Road. The house faces southwest. It is a two story, three bay by one bay gable-roofed structure intersection a two story single bay wide wing with a gable roof, gable end front. A single story shed section with a gable end facade roof is located on the facade of the main block. A single story shed addition is located at the rear, northeast elevation of the wing. The house is entered from both shed sections.

An interior brick chimney is located at the center of the rear elevation of the main block. A central brick chimney is located on the wing. Three over one sash windows light the house with the exception of six over six windows in the rear elevaiton of the wing. The house rests on a rock-faced concrete block foundation. Weatherboard siding covers the house with standing seam metal on the roof.
